PROPERTY INSPECTION REPORT

Dynamic Property Inspection
1701 Cimarron Tr.
Grapevine, Tx 76051
817-442-9100

Inspected By: Stephen Ferguson 7807
Inspection Date: 6/23/2005

1701 Cimarron Tr.
Grapevine, TX 76092

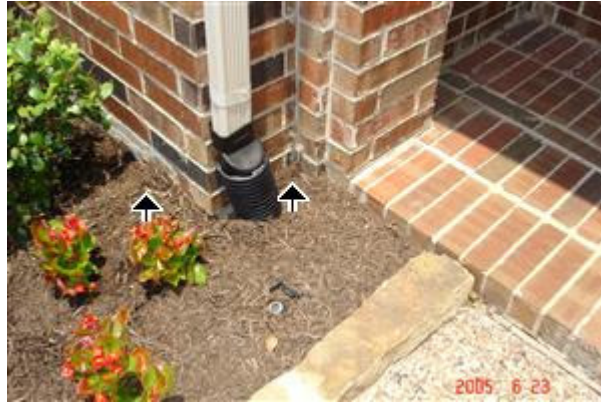
1.1 Picture 1

1. Grading high in flower beds around home. Grading should be 3 to 4 inches below brick.(See picture 1)
2. Ground moist around pool equipment area. Moisture appears to be coming from excessive water from sprinkler system. Inspected water meter at street to see if a leak sprinkler system was leaking. No leaks were detected at meter (meter did not run). Area that was moist does not get a lot of sunlight.(See picture 2)
3. Gutter down spout broke at back of home.(See picture 3).
4. Gutter sticking out of ground in back of home by flower beds. Homeowner told me that it is there for when the pool overflows it helps drain the water away from home. In my opinion it is either used for that or some type of french drain for the flower bed.

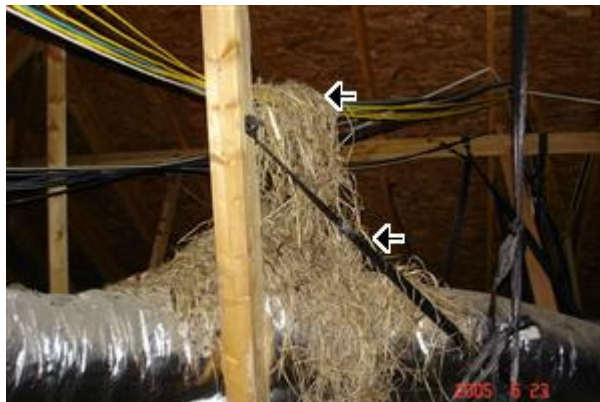
1.3 Picture 1

1. [Birds nest found in attic. They appear to be coming in from a vent directly above debris.\(See picture 1\).](#)

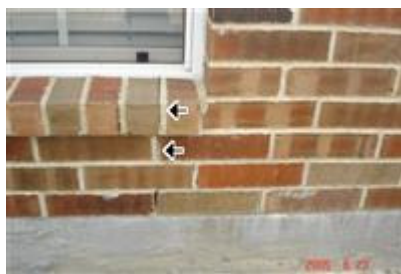
1.4 Picture 1

1. Brick mortar crack on west wall. (See picture 1).
2. Brick mortar cracked above double garage lintel.(See picture 2).
3. Siding pulling away from wall in back of home below chimney area. (See picture 3).
4. Bricks cracked at window ledge in game room on east and west window ledge's.(See picture 4& 5).

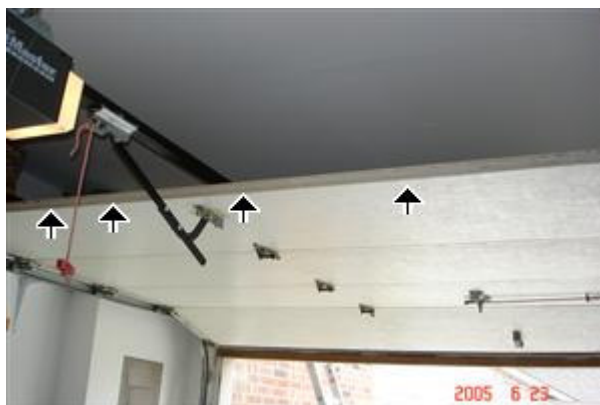
1.6 Picture 1

1. Garage door frame caulk is split and worn. Frame needs to be re-caulked.
2. Support beam missing on single garage door.(See picture 1)

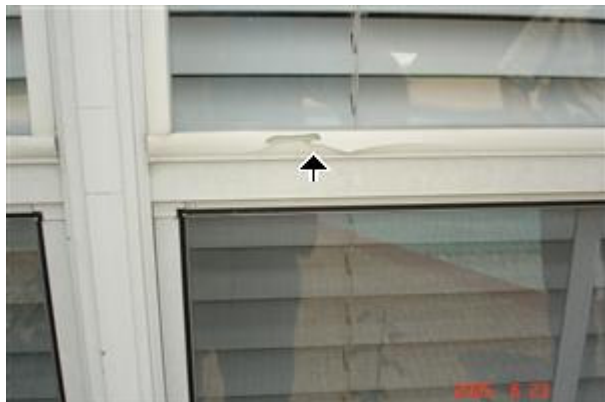
1.7 Picture 1

1. Weather stripping cracked on several windows in back of home.(See picture 1).

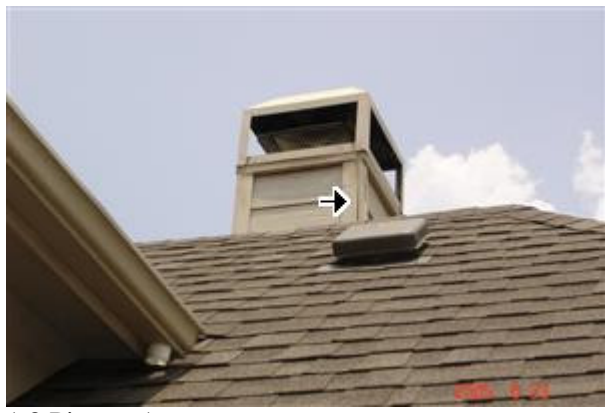
1.8 Picture 1

1. Wood trim pulling away from chimney. This needs re-nailed and caulked. (See picture 1).

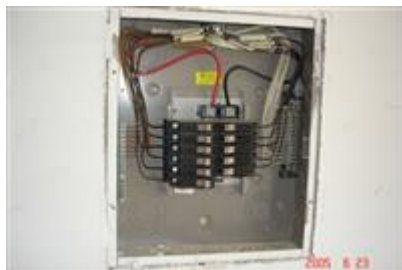
2.0 Picture 1

1. Remove panel board cover and inspected electrical panel. No defects were found.

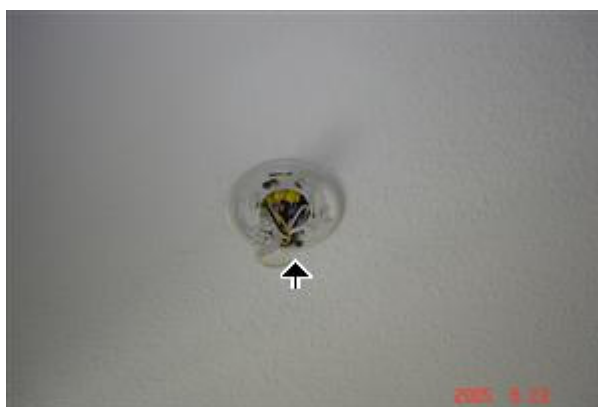
2.1 Picture 1

1. Smoke detector missing at upstairs hallway.(See picture 1).

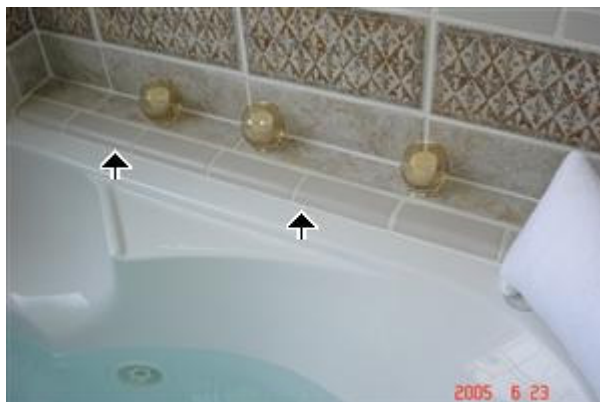
4.1 Picture 1

1. Toilet seats loose at both upstairs bathrooms and downstairs spare bathroom.
2. Grout cracked around Jacuzzi tub.(See picture 1)
3. Vent fan makes a vibrating noise in downstairs bathroom by garage.

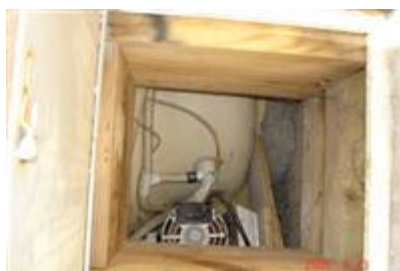
4.3 Picture 1

1. Please note that Jacuzzi tub GFCI outlet and reset is located in master closet.
2. Access plate of Jacuzzi tub is located outside by garage door. We opened and inspected this area and all was normal.

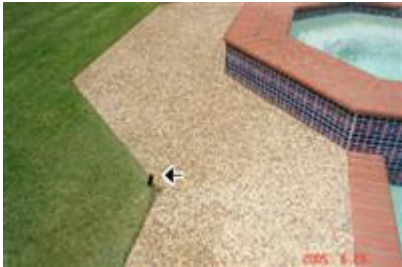
I	NI	NP	R	Inspection Items
				6 LAWN SPRINKLERS
<input checked="" type="checkbox"/>	<input type="checkbox"/>	<input type="checkbox"/>	<input checked="" type="checkbox"/>	6.0 SPRINKLER OPERATION <i>Comments:</i>
				1. One sprinkler head did not spray water located next to hot tub. (See picture 1).

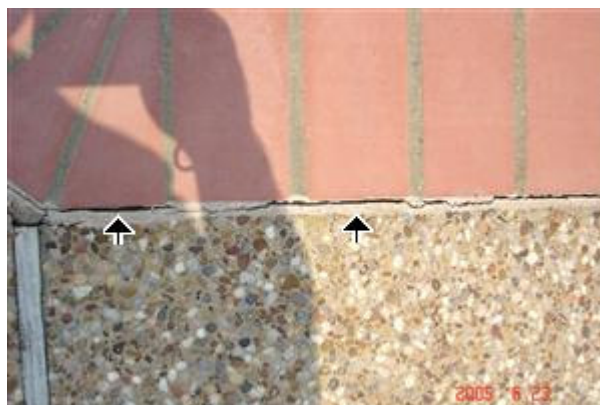
1. Small leak at pool filter.
2. Deco seal between red tile coping and deck is cracked and worn.(See picture 1).
3. No vortex drains at bottom of pool. This is a required safety item.
4. Flapper doors missing at both skimmers.
5. Grout cracked at several locations between blue pool tile and coping. (See picture 2).
6. Fence gates leading into pool area opens inward toward pool. This is required to open outward and latch needs to be 54 inches high.
7. Back door in home does not sound alarm when opened. This is also a required safety item for small children.
